## Emergency Welding & Repairs – Manufacturing

### United Kingdom

#### Project Overview

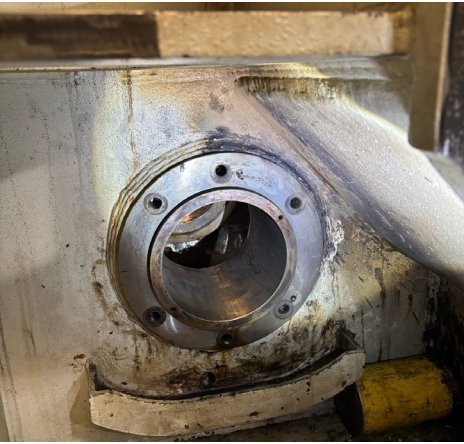
The complex scope-of-works, included the repair of deep cracks and defects in the press machine, measuring up to 55mm in 70mm thick steel, while navigating safety challenges related to a confined working space.

After deploying a team of welding experts, specialist partners, and an apprentice from our CRCE Apprentice Academy, we developed a detailed strategy and method statement covering gouging, crack removal, NDT, heat treatment, welding and final inspections, while working in close coordination with a specialist extraction and scaffolding team to create modifications around the machine, enabling the team to carry out work safely and effectively.
